NRL Memorandum Report 1913

Failure Analysis of Lift Pad Studs for the Recovery of Objects from the Ocean

H. L. SMITH AND J. A. KIES

August 1968

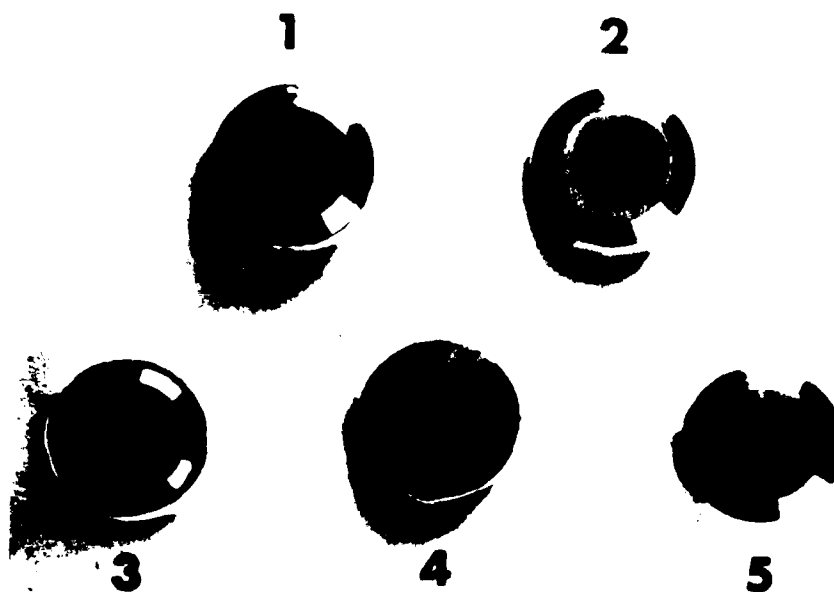
FIGURE 3

The test results are listed in Table 1. Unsymmetrical fatigue cracking probably was the cause of some eccentricity in loading as may be seen in Figure 3. Test No. 2 with a well-centered fracture gave $23,000 \text{ psi} \sqrt{\text{in}}$ as a probable value for K_{Ic} in air. In salt water, the stress-corrosion value of K_{Ic} , called K_{Isc} , was estimated to be less than the quantity of $20,000 \text{ psi} \sqrt{\text{in}}$ obtained for fracture with a short time rising load and more than the $9,000 \text{ psi} \sqrt{\text{in}}$ stress intensity value which caused no fracture in 16 hours (test No. 4). It is believed that the salt water environment lowered fracture toughness to some extent but the effect was not large at this low level of K_{Ic} .

PHOTOGRAPH OF FRACTURED TEST SPECIMENS

The numbers refer to tests in Table I. The inner most region with a freshly-separated appearance was assumed to be the area of fast fracture. The surrounding fatigue precrack was smoother and sometimes slightly stained. Only test No. 2 had a well-centered and a nearly circular area of fast fracture.

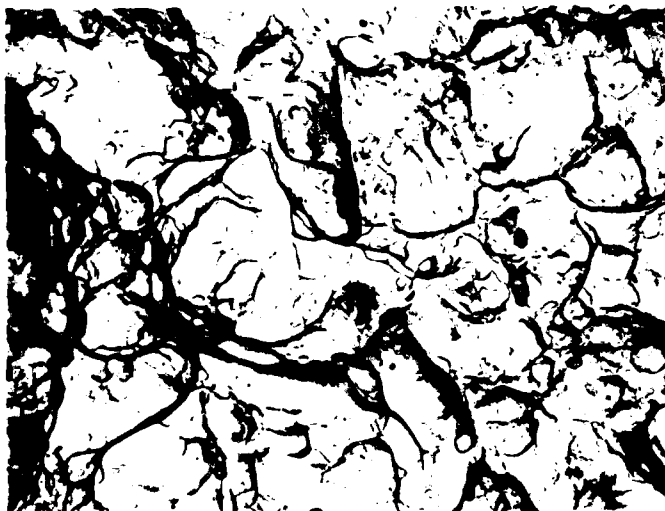
B. ELECTRON FRACTOGRAPH FROM FAST-FRACTURE
AREA OF TEST NO. 2

Some additional metallurgical factors were examined. The typical microstructure of acicular martensite is illustrated in Figure 4A. A zephiran etch showed no indication of temper brittleness. The electron fractograph of a K_{Ic} test fracture in Figure 4B indicated a relatively ductile type of separation that might be expected of a steel with a high yield strength. Small corrosion pits were observed running perpendicular to the fracture surface in a failed stud supplied by NOL (Figure 5A). These pits apparently were developed in the sea water after the stud had fractured in the pull test. A similar pitting attack might have occurred at the surface of the stud during the pull test. Pitting at the surface is the usual start of stress-corrosion cracking of a smooth metallic part (6). Stringer inclusions (Figure 5B) extended in the same direction as the pits but the evidence was insufficient to establish a direct relation.

The surface consisted largely of flat areas perpendicular to the stress field. There were indications of ductile dimpling but no clear evidence of brittle cleavage or intergranular fracture

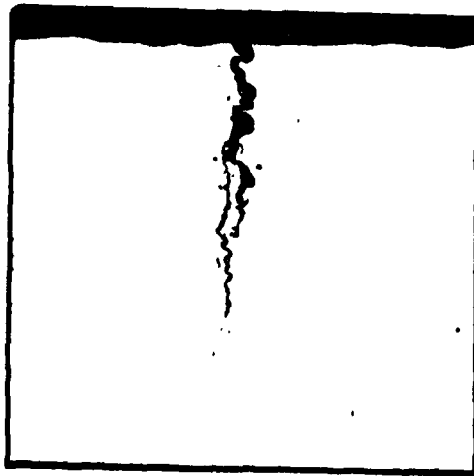
In salt water, the steel in the studs was subject to pitting from corrosive attack. A very small flaw combined with a high local stress could have initiated fracture at a low average stress level according to fracture toughness relations.

A. Cross section at the fracture surface illustrating corrosion pitting which developed after fracture in sea water at NOL.

CORROSION PITTING AND STRINGER INCLUSIONS
Unetched, X100

The application requires a high-strength metal resistant to sea water attack with properties suitable for ballistic penetration. The nickel-chromium base alloy Inconel 718 reportedly is under consideration. The nickel-cobalt-chromium-molybdenum alloy MP35 was suggested in (1). After working and aging, these alloys can be strengthened to about 260,000 psi. Both metals have good resistance to corrosion. Vacuum melting in steel manufacturing would also be beneficial due to a decreased number of inclusions. However, according to all available information no steel exists today which is safe for this application unless the tensile yield strength is 180,000 psi or

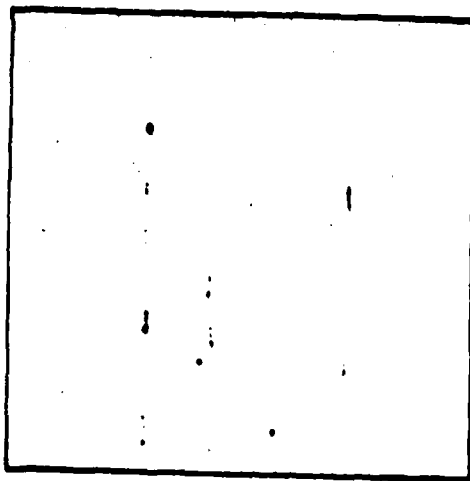
B. Area in the body of the steel stud showing typical stringers of inclusions extending in the same direction as the corrosion pits.
